# **DEMONSTRATION OF THE ELECTRIC CURRENT PERTURBATION TECHNIQUE FOR FATIGUE CRACK CHARACTERIZATION IN TF-33 TURBINE DISK TIEBOLT HOLES**

## **FINAL REPORT**

November 1979

**SOUTHWEST RESEARCH INSTITUTE**  
**Houston**  
**San Antonio**

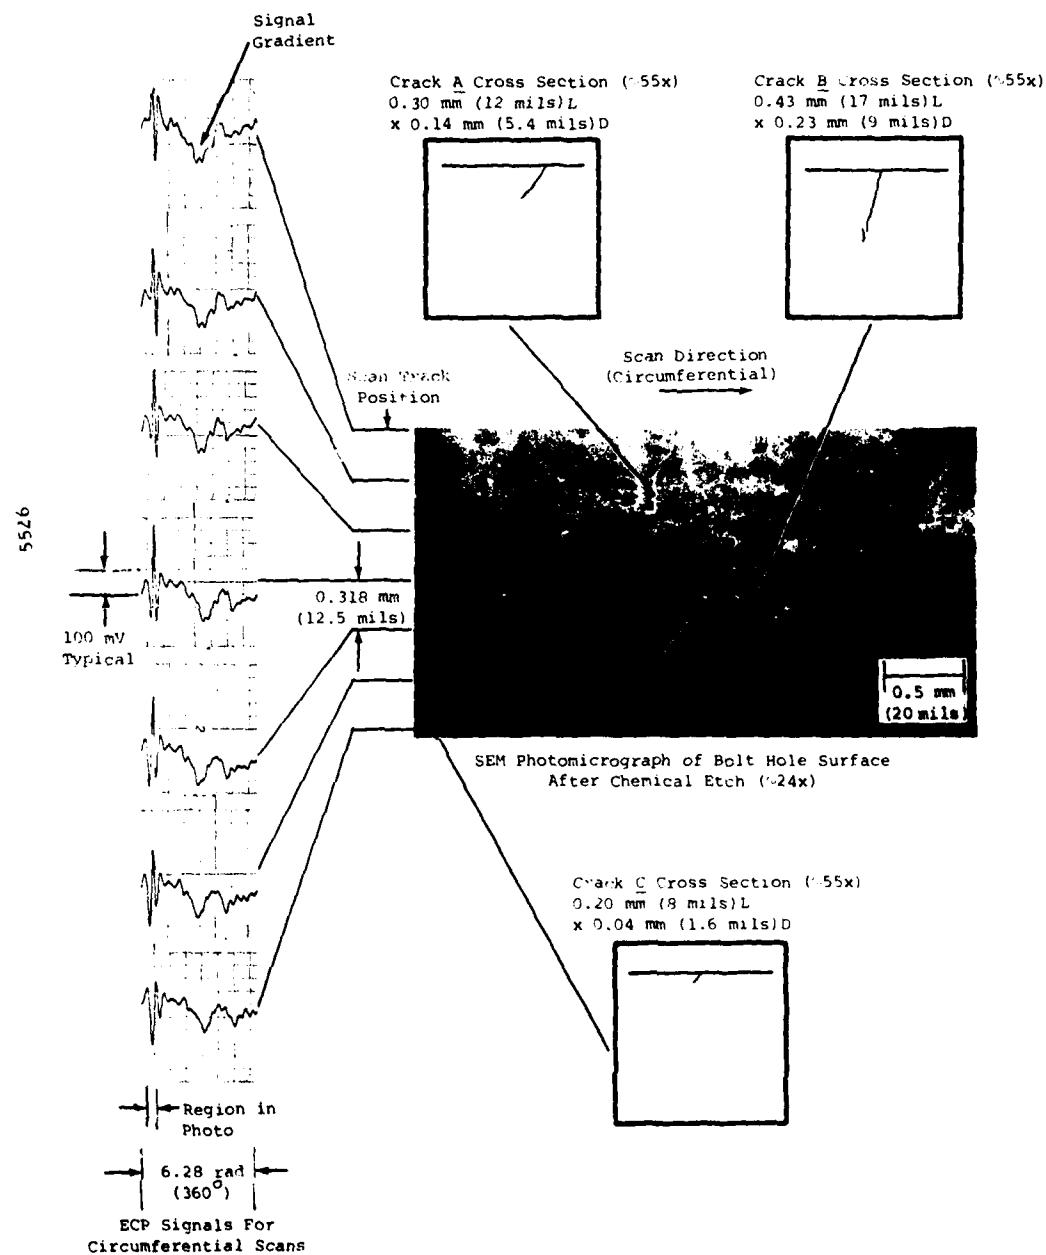
Figure 12 shows a surface photograph of cracks near the top end of Hole J, with a sketch of the subsurface geometry of each crack; crack dimensions; and ECP signatures obtained at the designated scan track positions. Figures 13, 14, and 15 are photographs of the subsurface cross sections of each crack. Note that the ECP scans for the entire circumference of the bolt hole are shown and that the region in the photograph comprises only a small segment of the overall ECP signature. Also, since these scans are near the top of the hole, a slight gradient is still present in the signal near the center of each trace.

Because of the complex crack geometries and the close spacing of the cracks, it is believed that there exists a significant amount of signal interaction from one crack to the next with the present probe. The cracks shown in Figure 12, however, exhibit some of the simplest subsurface crack geometries of any of the cracks in the specimen. Also, Crack A is somewhat isolated (no significant cracking exists between it and the top of the hole), and it is therefore believed that the signal amplitude at its location is not greatly influenced by other cracks.

Signal analysis shows that as the ECP scans approach Crack A from the top, the ECP crack signal is first downward going (negative) and then the signal reverses polarity for successive scan track positions axially along the crack and past the bottom end. A positive polarity is then obtained near the top of Crack B. As the scan moves over Crack B and toward its bottom end, the signal again reverses polarity and also becomes broader in a circumferential direction, probably due to the influence of Crack C. The other small cracks shown in the photograph and additional cracks located further down the hole (not shown) may be influencing the signal as well.

It can be seen that the distribution of peak-to-peak amplitudes from these two cracks behaves in a manner similar to the previously presented experimental data for two closely-spaced cracks (see Figure 10). Also note that the signal amplitude obtained from Crack B is slightly larger than that obtained from Crack A due to the larger size of Crack B.

FIGURE 12. CORRELATION OF SURFACE PHOTOMICROGRAPH, CROSS SECTIONAL SKETCHES AND ECP SIGNALS FOR CRACKS A, B, AND C IN SPECIMEN J

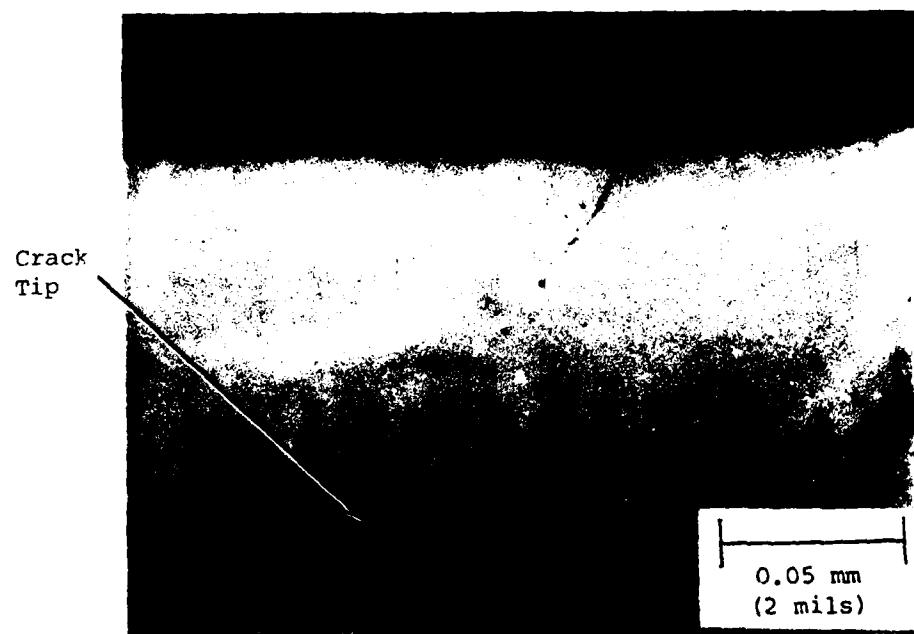
FIGURE 13. OPTICAL PHOTOMICROGRAPH OF CRACK A CROSS SECTION (~500x)

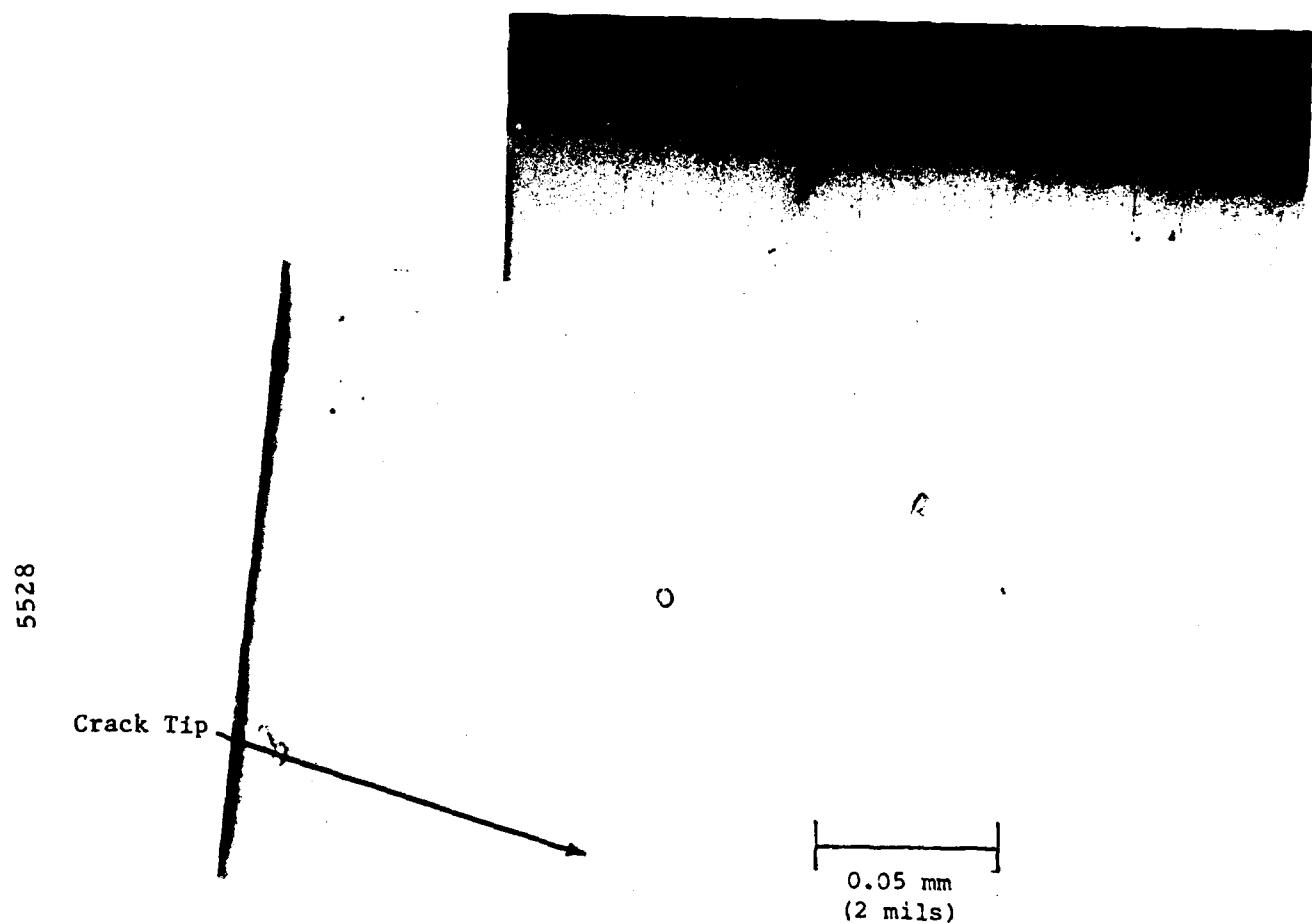
FIGURE 14. OPTICAL PHOTOMICROGRAPH OF CRACK B CROSS SECTION (~500x)

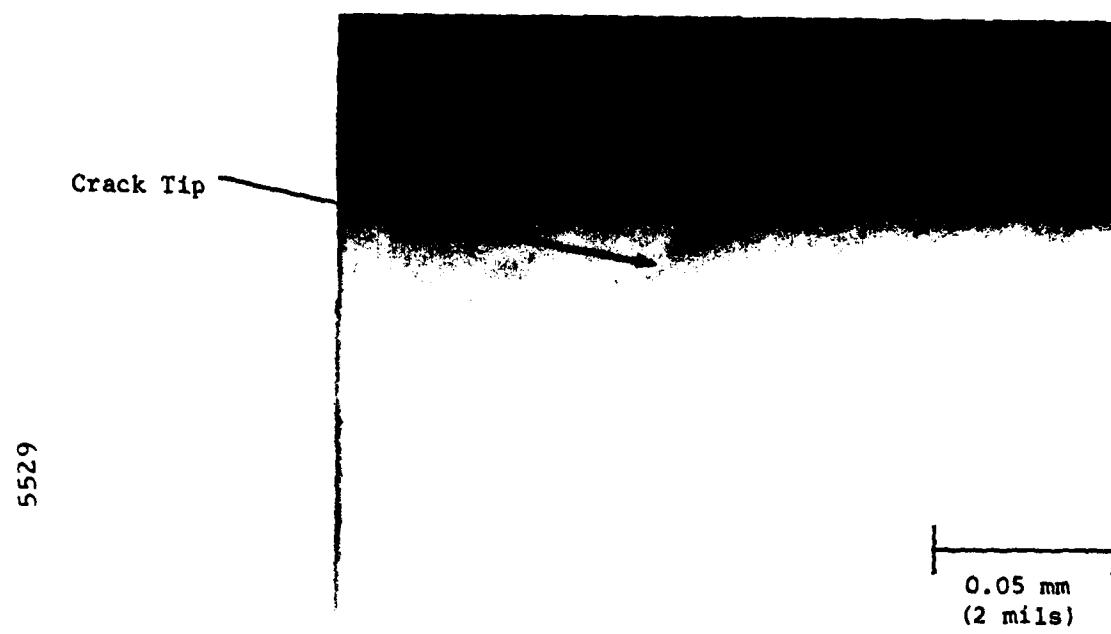
FIGURE 15. OPTICAL PHOTOMICROGRAPH OF CRACK C CROSS SECTION (~500x)

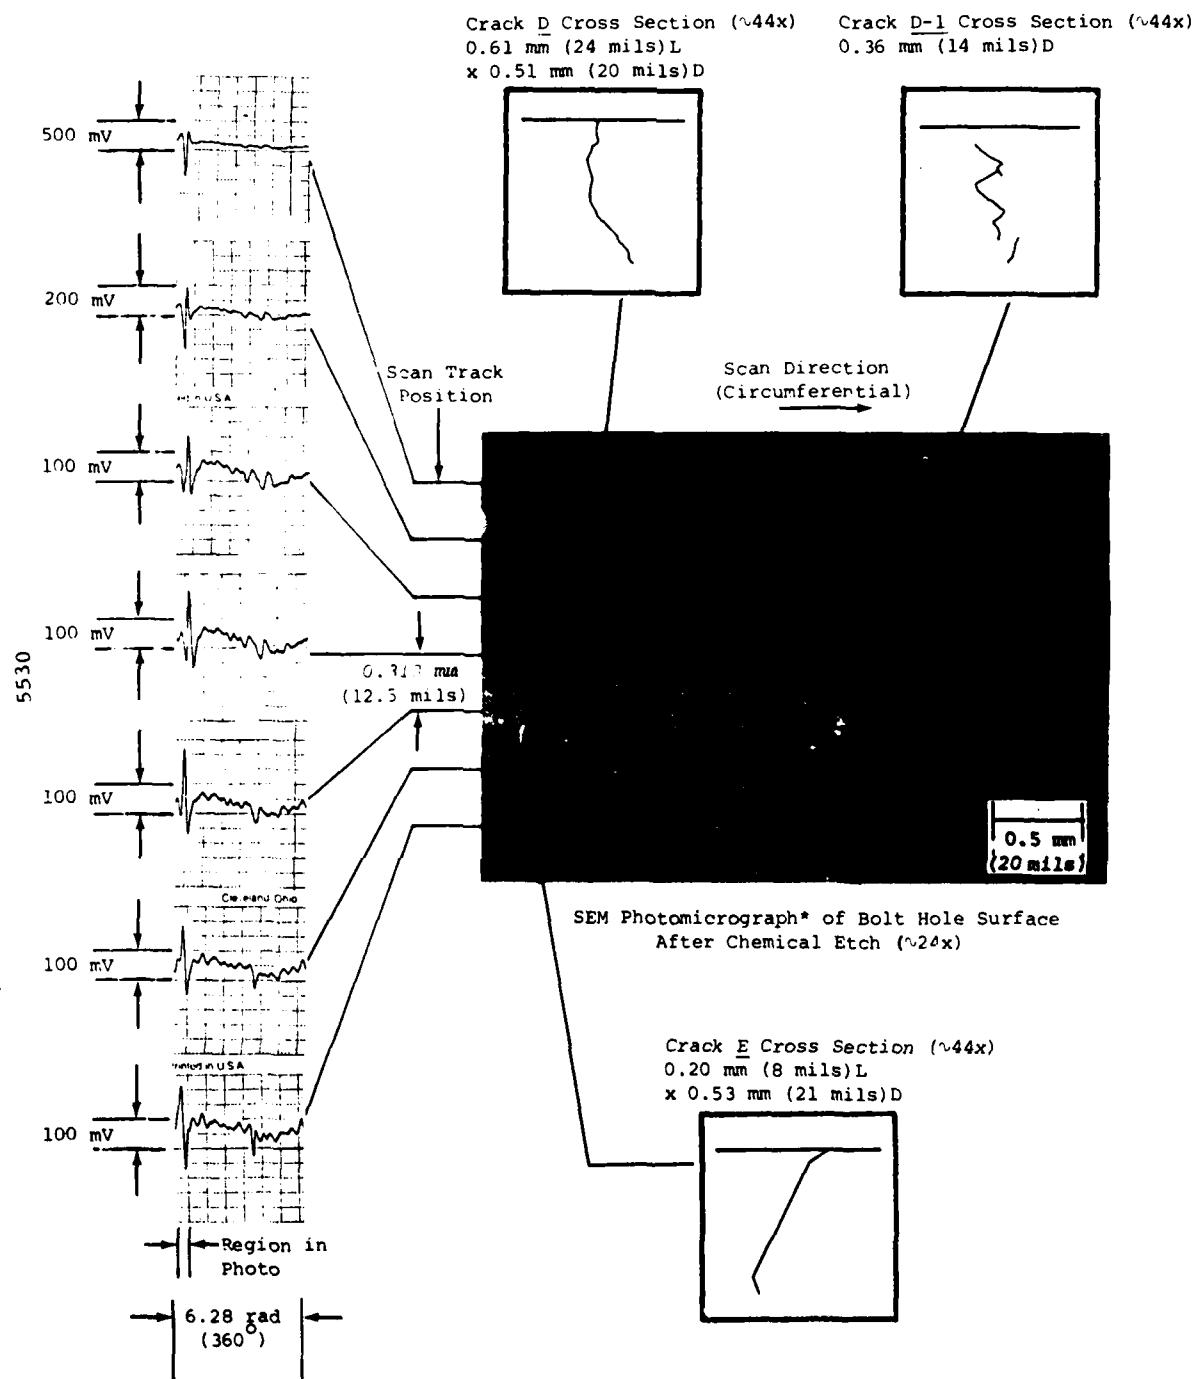
Figure 16 shows results from additional cracks at a position further into the hole, and Figures 17, 18 and 19 are the subsurface cross section photographs of each crack. Although several cracks are evident in this photograph, the response in this area appears to be dominated by Crack D, which is relatively long and deep. Note that

FIGURE 16. CORRELATION OF SURFACE PHOTOMICROGRAPH CROSS SECTIONAL SKETCHES AND ECP SIGNALS FOR CRACKS D, D-1, AND E IN SPECIMEN J

signal polarity reversal is obtained in the region of this crack. Other interesting crack characteristics are also shown in this figure. For example, Crack D-1 has no surface indication at all and could possibly be a continuation of Crack D under the surface. Also note the complicated subsurface geometry of Crack D-1. Crack E, which has a very short surface length, exhibits unusually great depth. It can also be seen that near the bottom of the photograph (Figure 16) the signal is bipolar. The concentration of deep cracks in this region and the fact that subsurface cracking exists with no apparent surface indication undoubtedly contributes to the complex signal characteristics in this region. Cracks which exist past the ends of the photograph may further contribute to signal complexity.

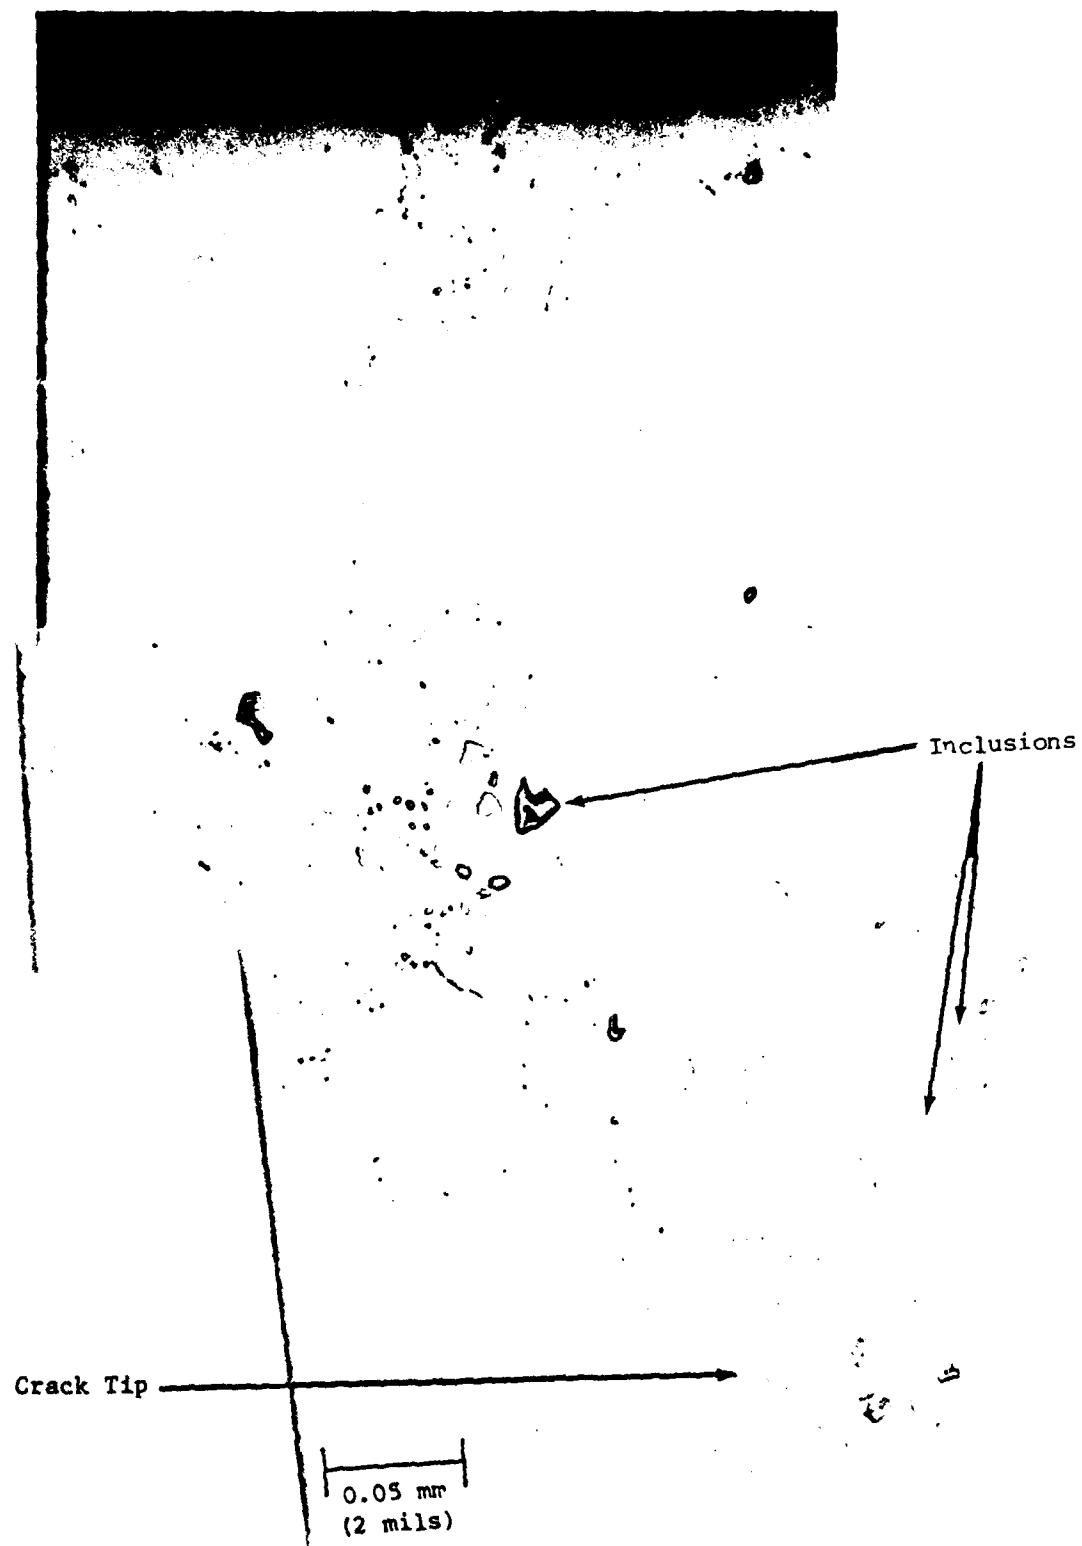
FIGURE 17. OPTICAL PHOTOMICROGRAPH OF CRACK D CROSS SECTION (~400x)

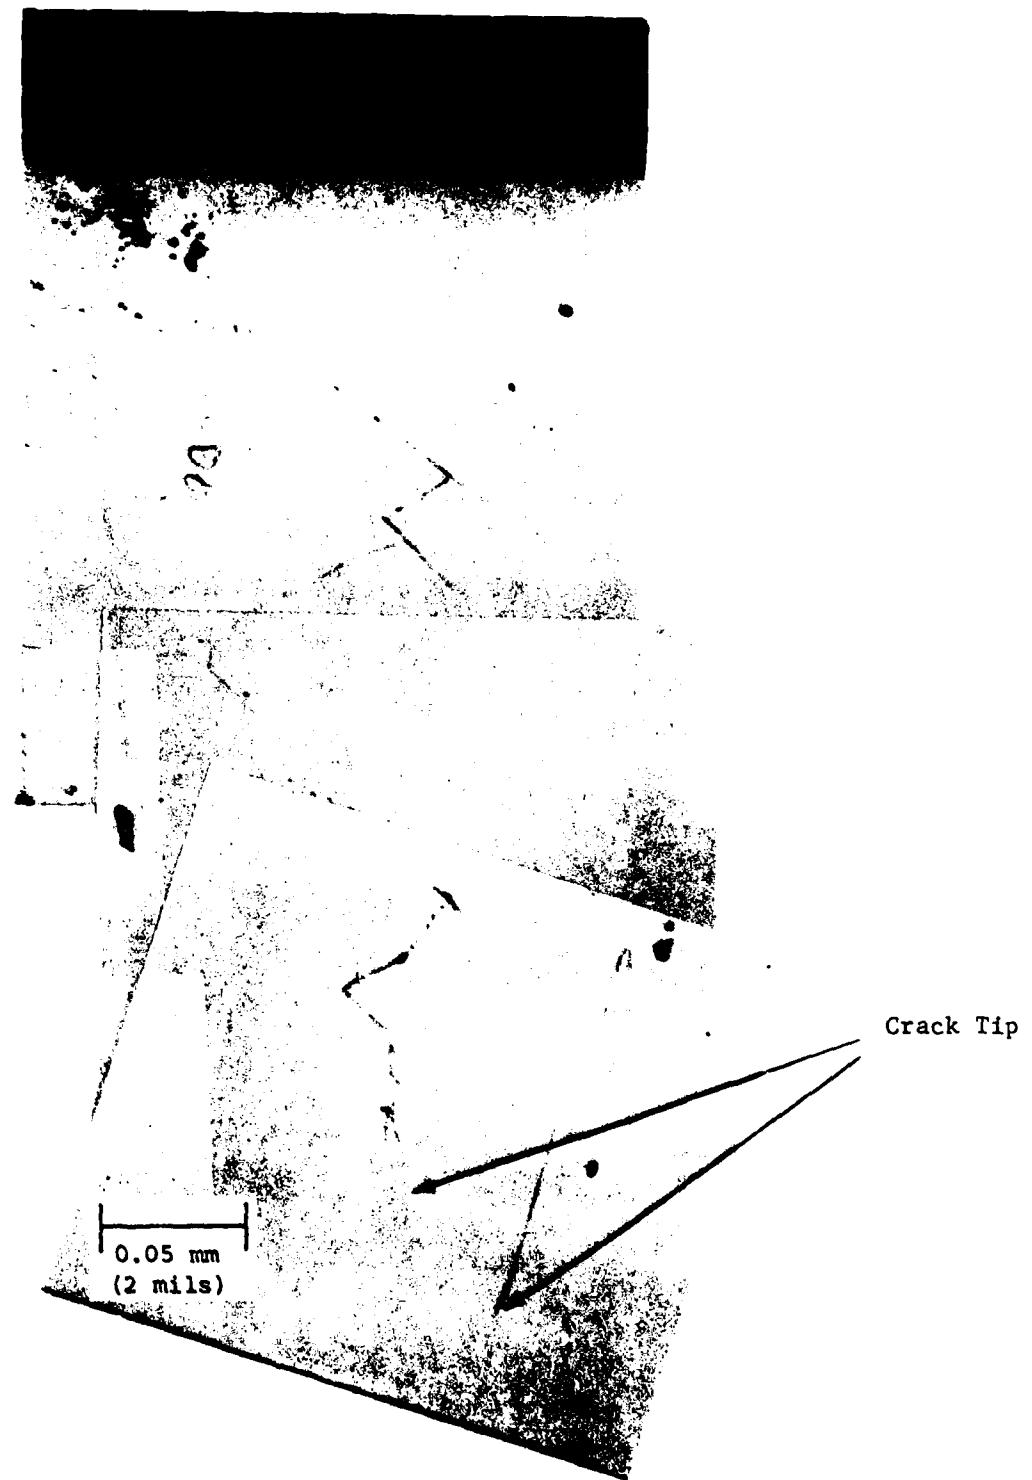
FIGURE 18. OPTICAL PHOTOMICROGRAPH OF CRACK D-1 CROSS SECTION (~400x)

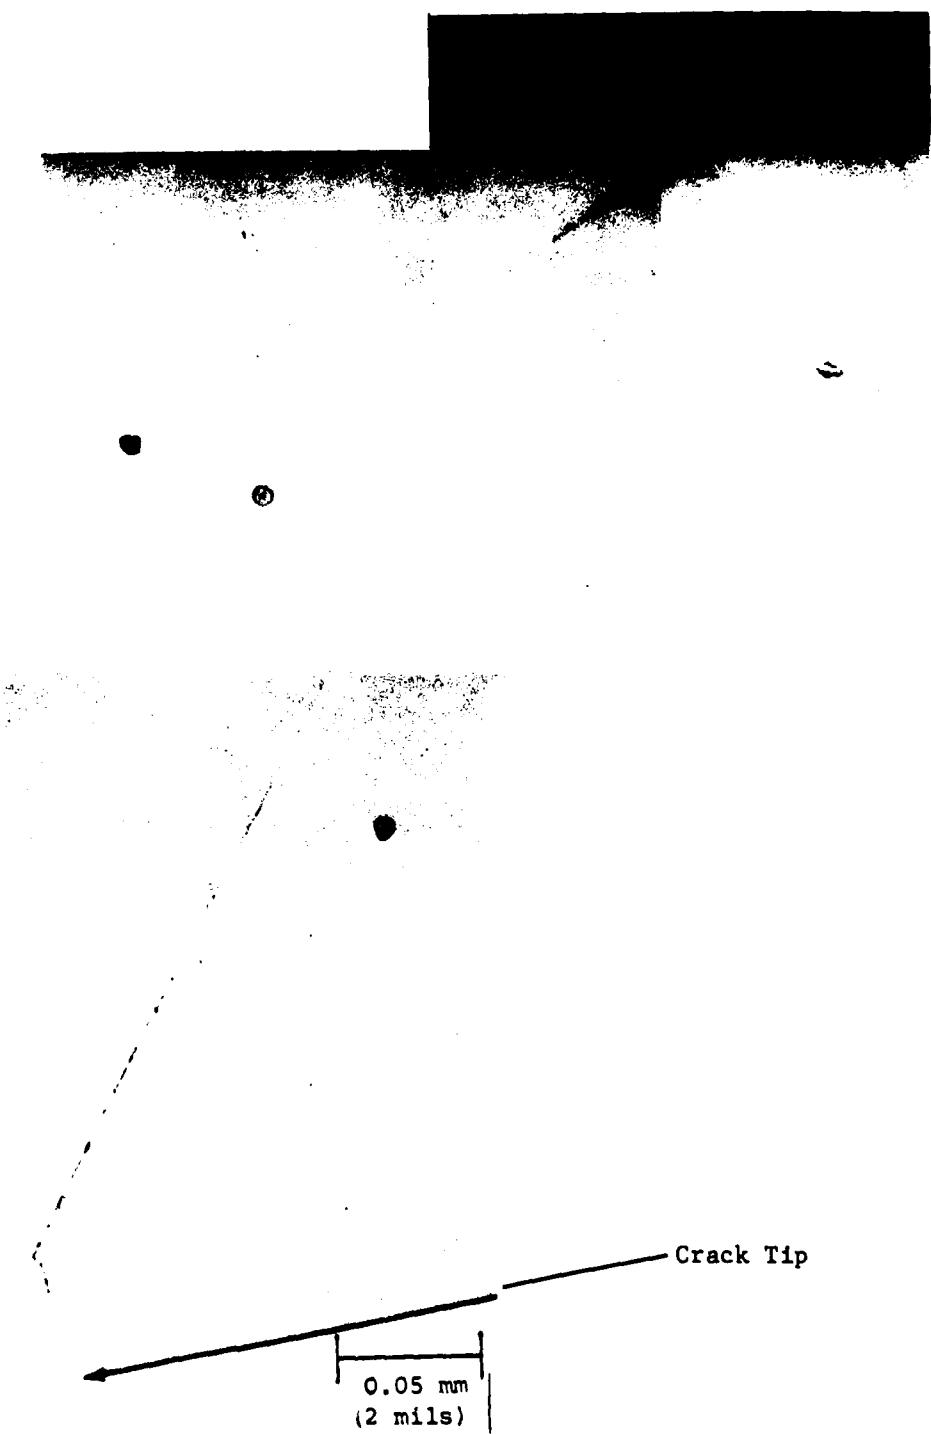
FIGURE 19. OPTICAL PHOTOMICROGRAPH OF CRACK E CROSS SECTION (~400x)

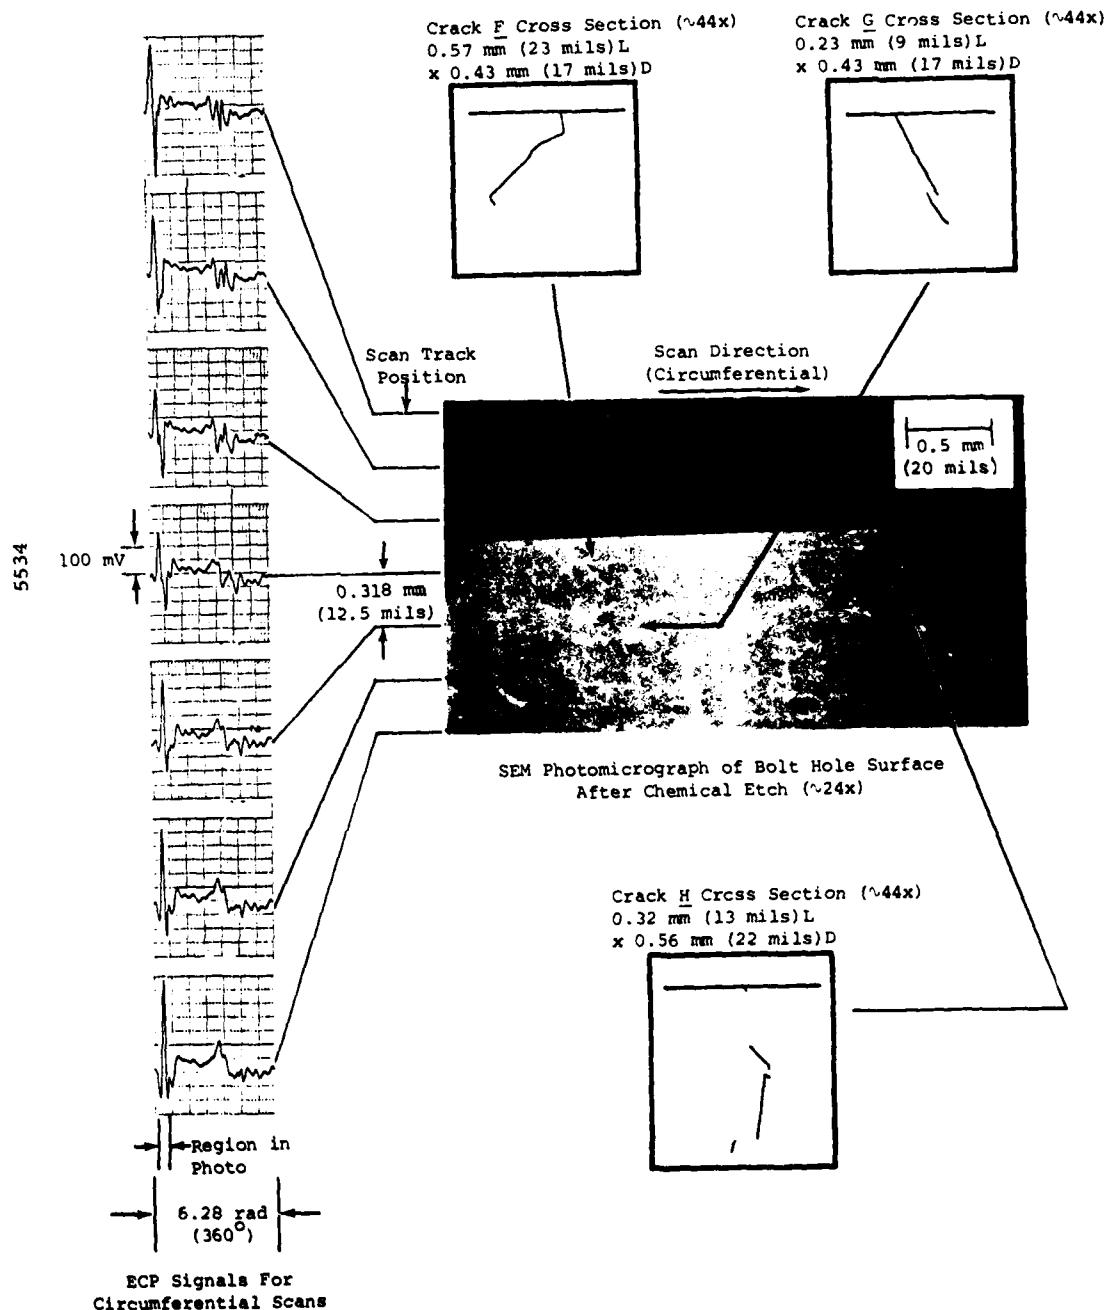
Figure 20 shows another region of Hole J where several more cracks exist in proximity, and Figures 21, 22 and 23 are the crack cross section photographs. Near the top of the photograph in Figure 20 the signal is bi-polar in characteristic, indicating interaction between two crack signatures. The negative portion of the bi-polar signal could be a component of the signature from Crack F, which reverses polarity and becomes positive as the scan position moves to the bottom end of the crack. Some broadening of the circumferential width of the crack signature is introduced by Crack H, which is at a different circumferential position than Crack F. Although no distinct signal indication was obtained which distinguishes between Cracks F and G, the spacing between these cracks is very close as compared to their lengths, and also Crack G is much deeper than it is long, indicating that the entire crack length may not be evident on the surface. The subsurface view of Crack H is also interesting in that a short crack indication was obtained immediately below the surface and several long indications were obtained at a significantly greater depth below the surface.

FIGURE 20. CORRELATION OF SURFACE PHOTOMICROGRAPH, CROSS SECTIONAL SKETCHES AND ECP SIGNALS FOR CRACKS F, G, AND H IN SPECIMEN J

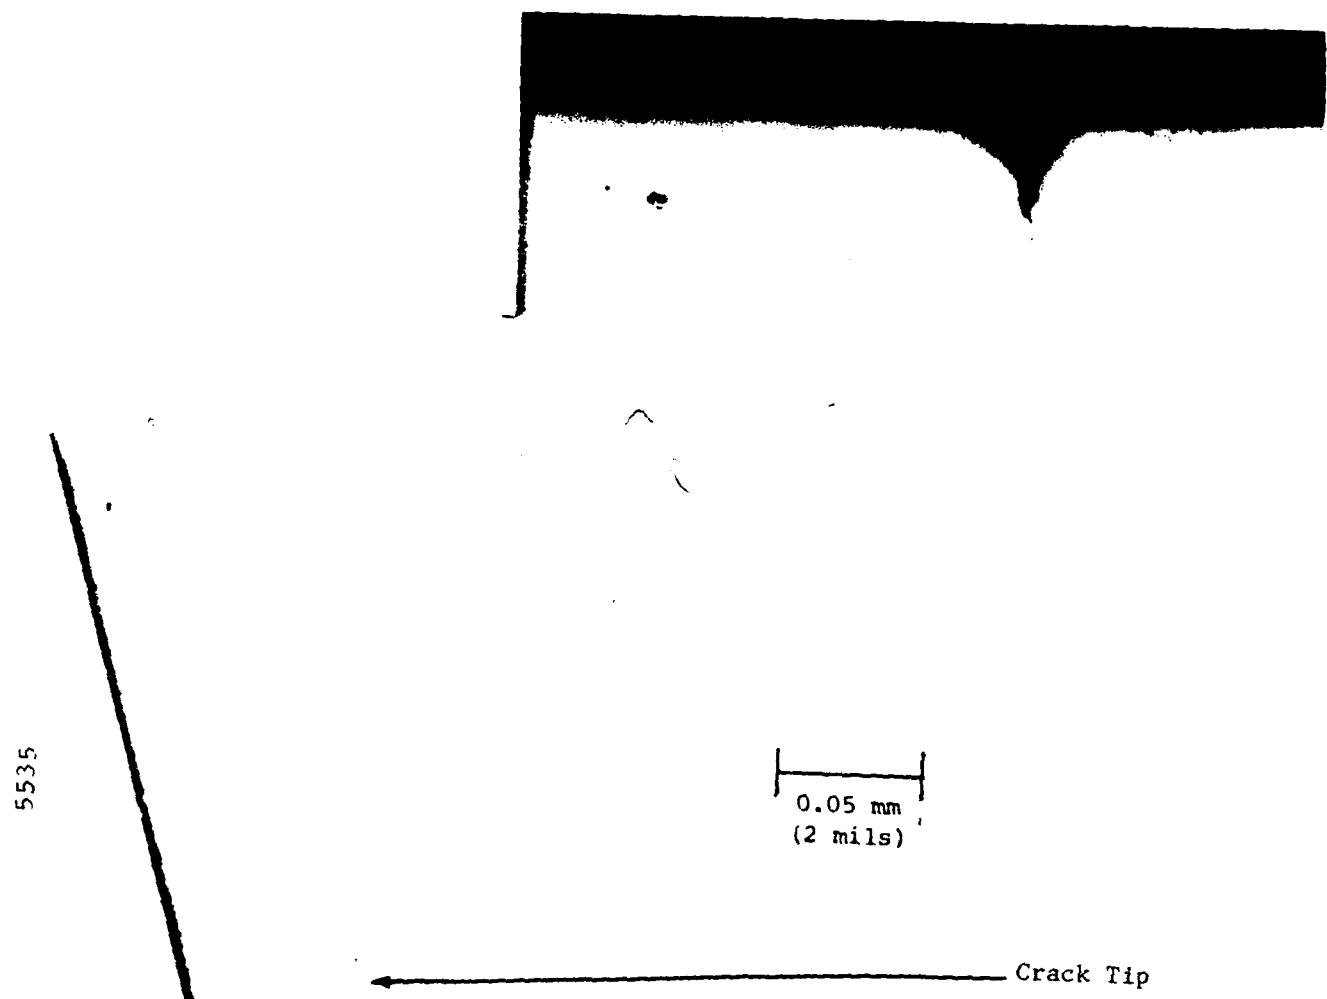
FIGURE 21. OPTICAL PHOTOMICROGRAPH OF CRACK F CROSS SECTION ( $\sim 400x$ )

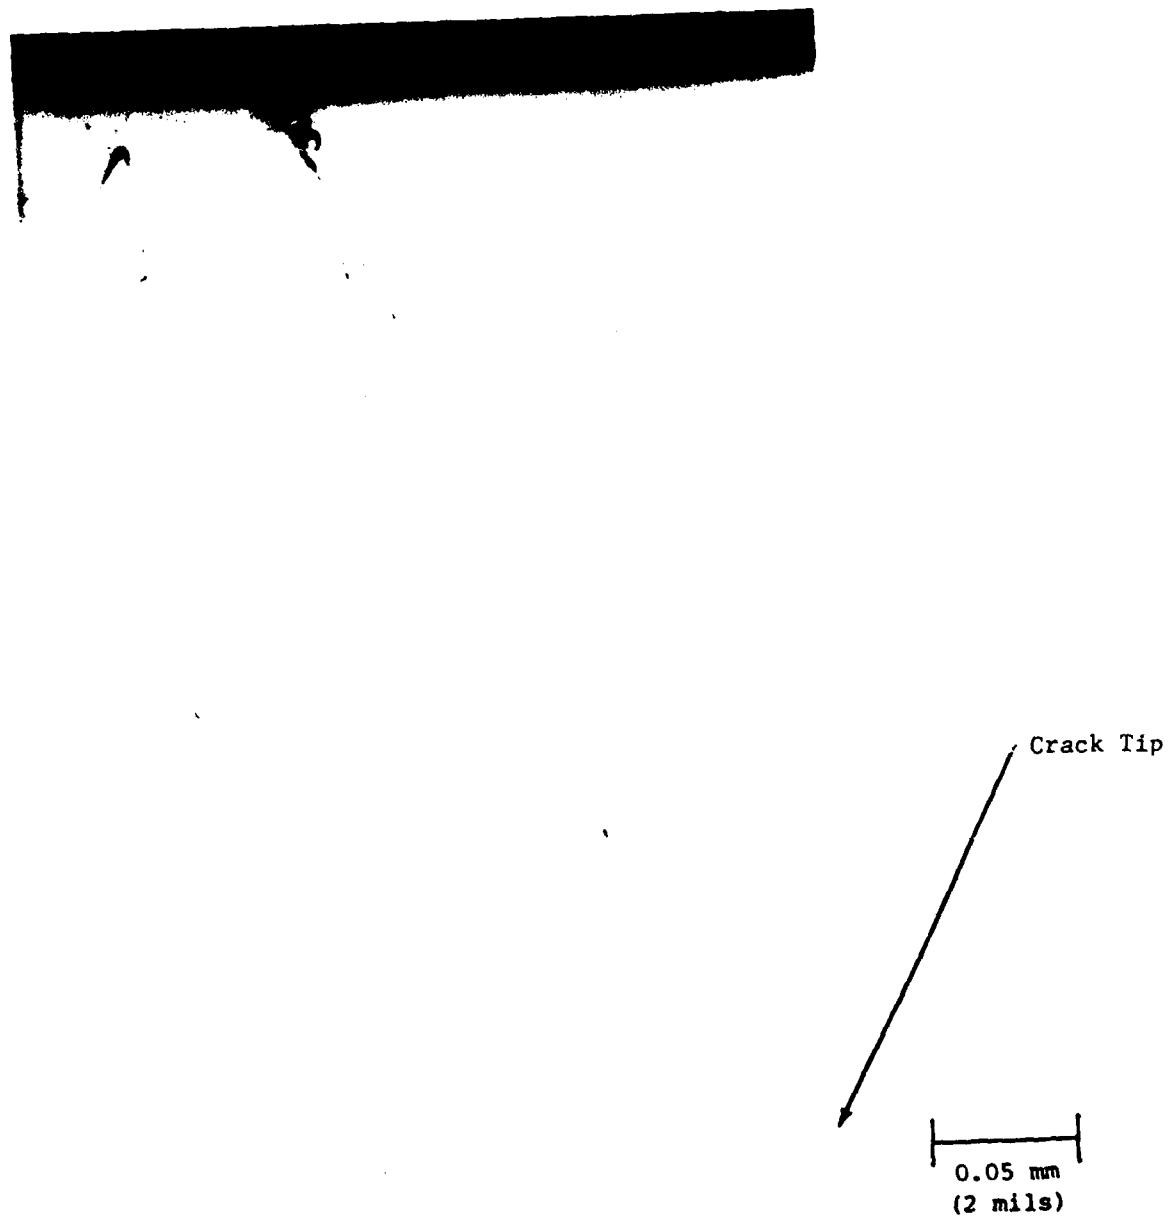
FIGURE 22. OPTICAL PHOTOMICROGRAPH OF CRACK G CROSS SECTION (~400x)

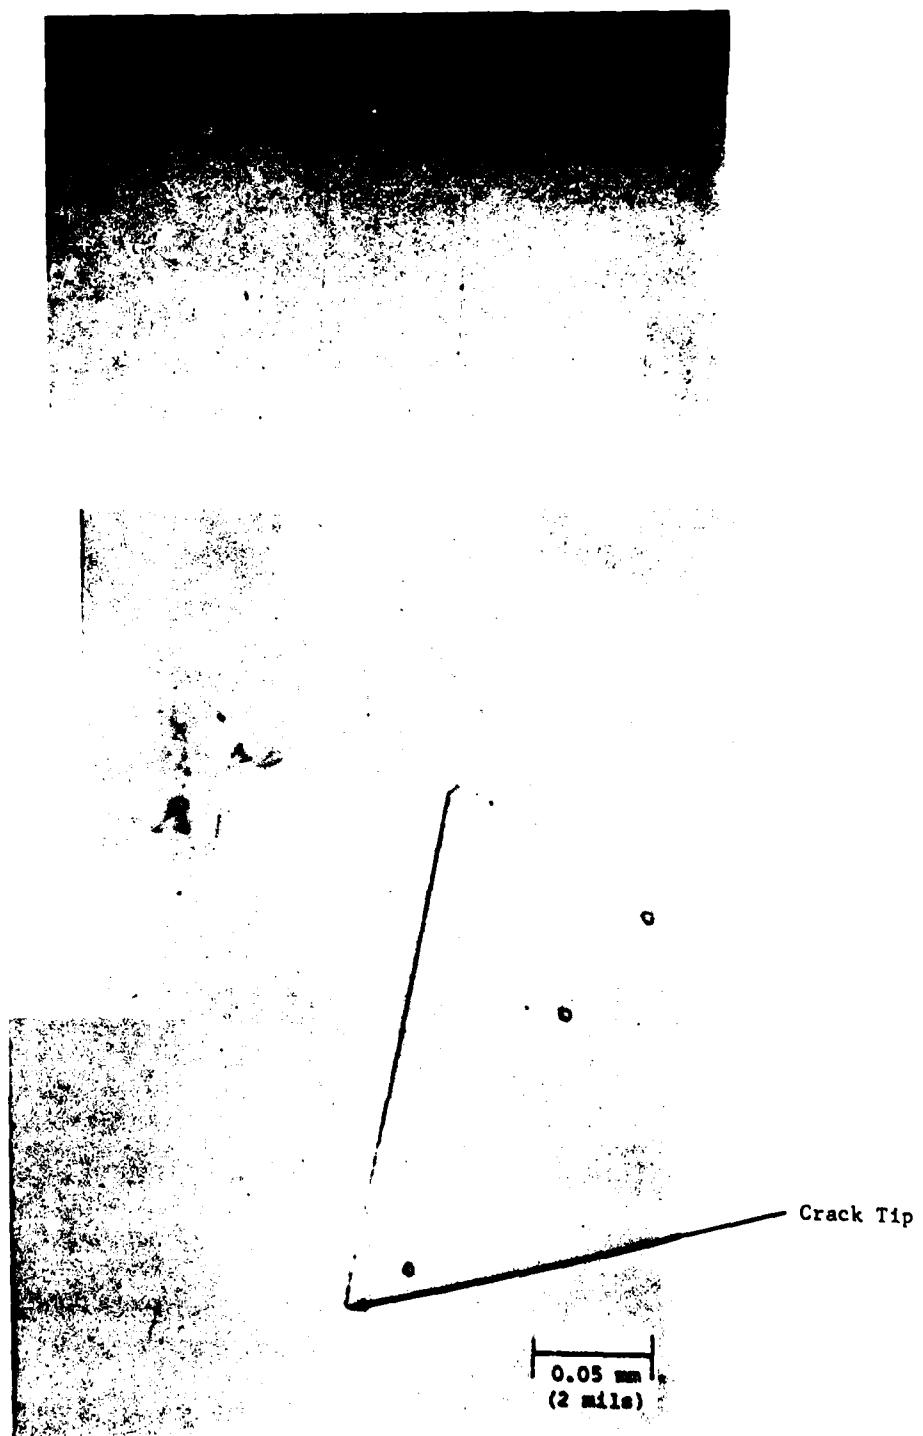
FIGURE 23. OPTICAL PHOTOMICROGRAPH OF CRACK H CROSS SECTION (~400x)

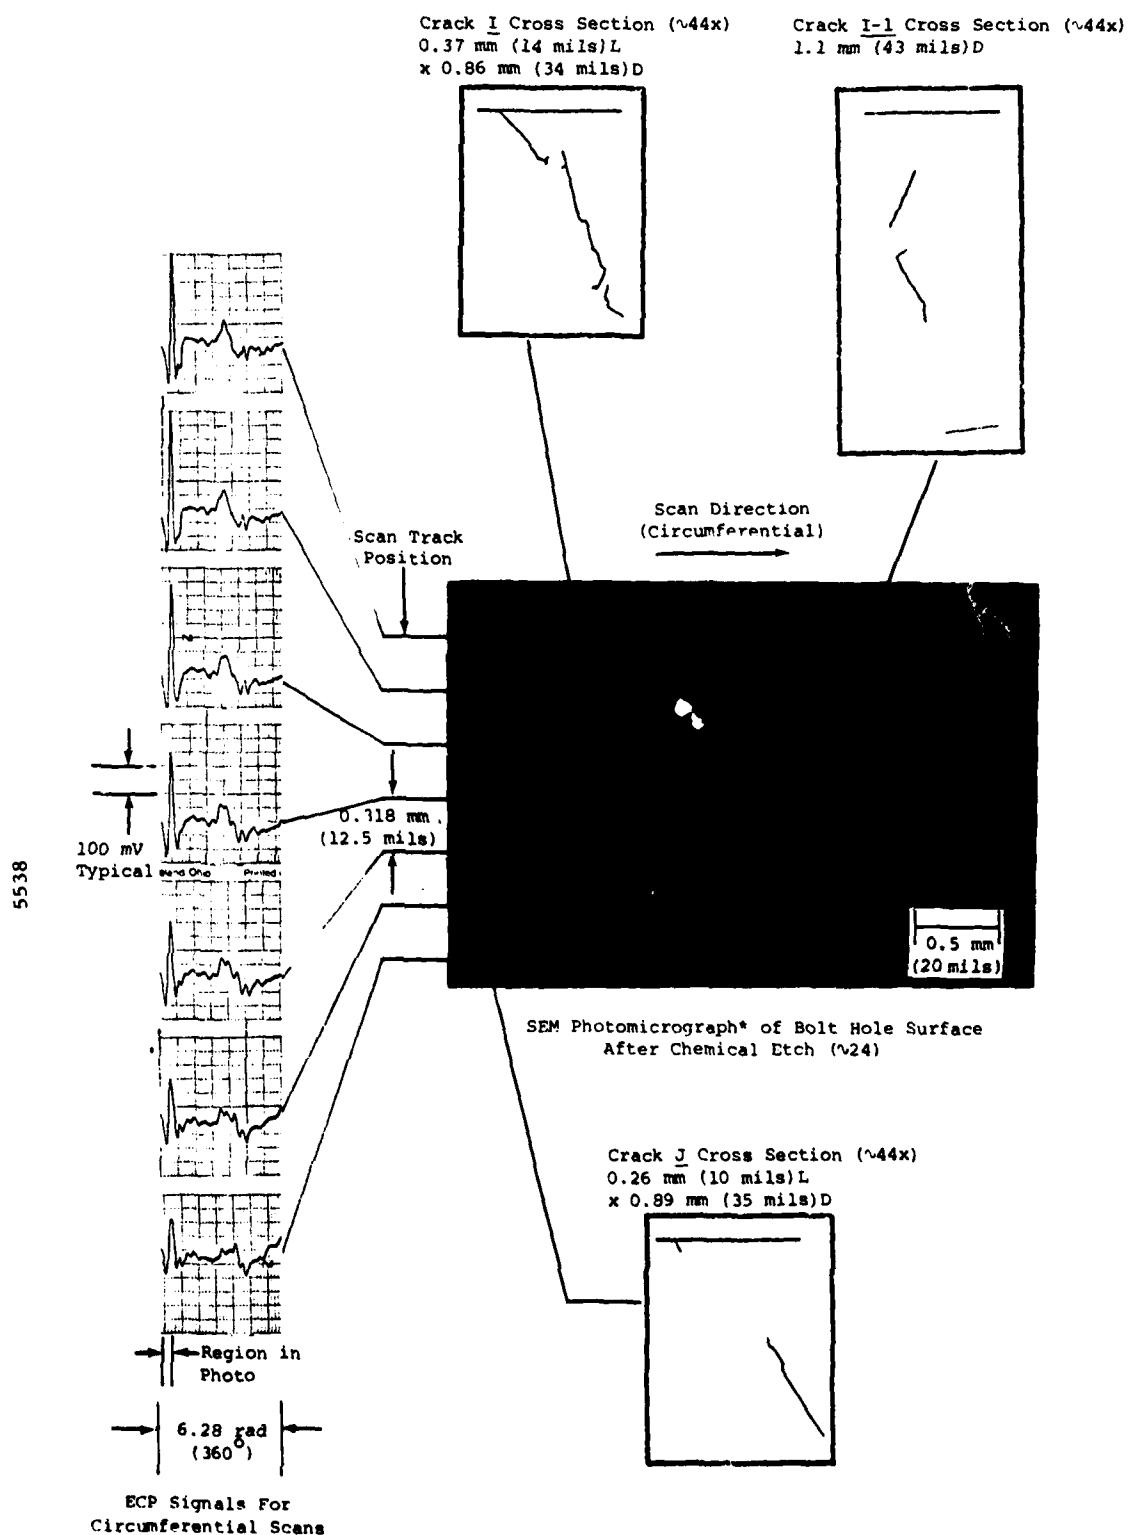
Data for the next set of cracks in Specimen J are shown in Figure 24 with crack cross section photographs shown in Figures 25, 26, and 27. Although two surface crack indications were obtained in this region, there appears to be a high degree of subsurface cracking throughout the entire area. Note that Crack I has one surface-connected portion and another very large, completely subsurface region. Crack I-1 has no surface indication at all, but exhibits three areas of subsurface cracking. Crack J has only a small surface indication, but a relatively large subsurface depth. It is possible that the deep subsurface cracking shown in all three of these cross sections could, in fact, be one portion of a large network of subsurface connected cracks. Unusual ECP signal characteristics were also obtained in this region, probably due to the high degree of subsurface cracking. Note that the signal is always positive going at all increments along the crack and does not reverse polarity; however, the signal does build to a maximum in the region of Crack I, which has the longest subsurface indication that is still connected to the surface.

FIGURE 24. CORRELATION OF SURFACE PHOTOMICROGRAPH, CROSS SECTIONAL SKETCHES AND ECP SIGNALS FOR CRACKS I, I-1, AND J IN SPECIMEN J

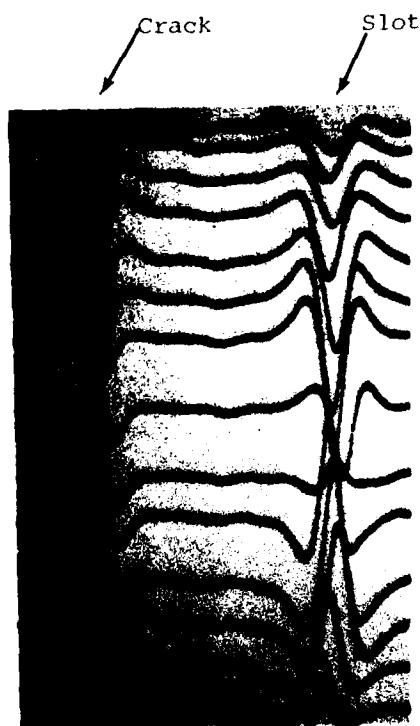
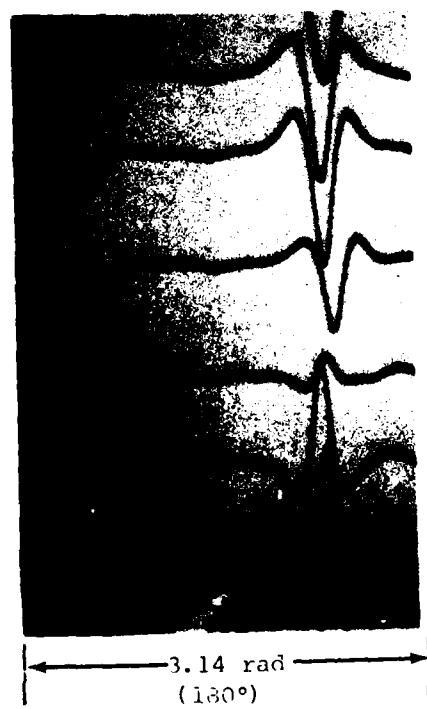
The first approach consisted of an A-scan image where a series of ECP signatures were displayed simultaneously on a cathode ray tube. Figure 28 shows two views of this data presentation on Hole F which contains both the 0.64 mm (25 mils) x 0.23 mm (9 mils) slot and also a fatigue crack as designated in the figure. Figure 28A shows a series of closely-spaced scans in a region around the center of the defects while Figure 28B shows the same scans at a coarser spacing used to separate signal features. This type of presentation can be very useful since signal features on a series of scans can be viewed simultaneously, and important characteristics such as signal reversals and signal amplitude changes can be seen as a distribution along the axial length of the defect.

FIGURE 28. A-SCAN IMAGES OF ECP SIGNATURES FROM HOLE F,  
DISK 6S7833 SHOWING A CRACK AND A SLOT. SCAN  
SPACING IS 0.32 mm (12.5 mils)

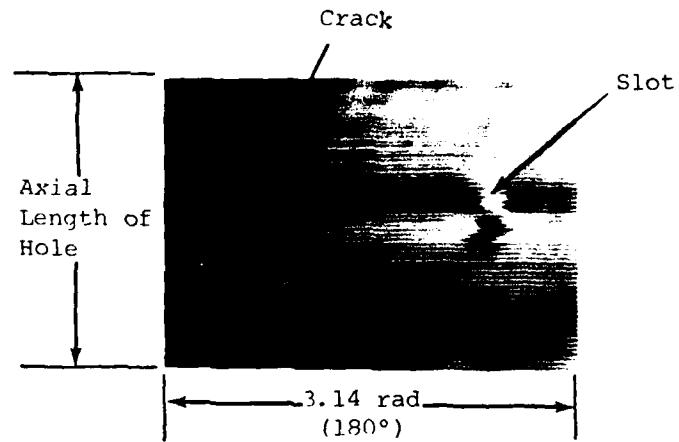
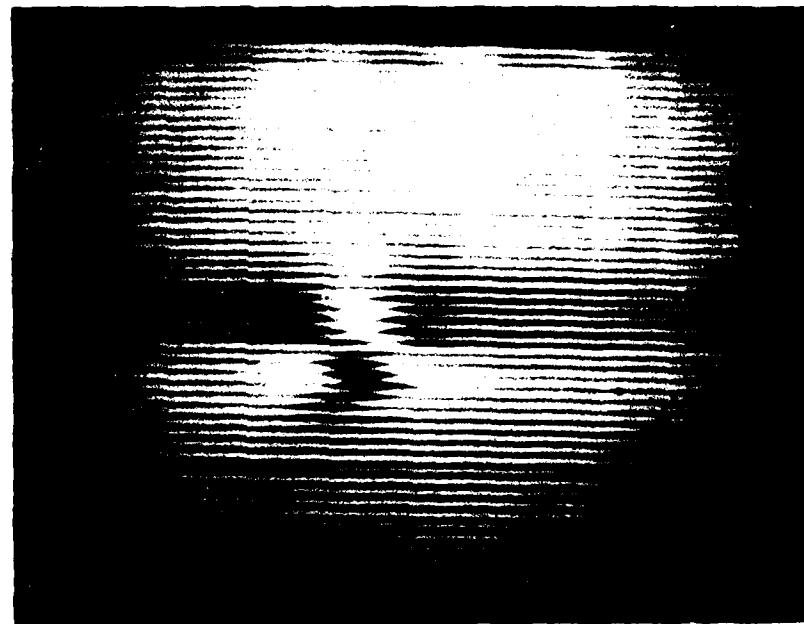
Another potentially useful imaging technique is a C-scan display in which the signal amplitudes are represented by shades of gray scale. The photograph in Figure 29A shows the C-scan presentation of the entire length of the hole and approximately one-half its circumference. The white areas in the photograph represent regions of maximum negative signal polarity while the black regions represent regions of maximum positive polarity, and shades of gray represent intermediate regions. The crack signature is on the left and the slot signature is on the right. Notice that the crack signature is relatively complex, while the slot signature shows distinctly the signal reversal in the rapid change from white to black. The image is somewhat smeared horizontally due to difficulties in precisely synchronizing the display with the ECP data with the rudimentary setup used here. Also, the horizontal dark bands in the photograph were caused by D.C. offsets in the data signals and are of no significance in the data interpretation. These problems can be easily corrected with additional system refinement. The photograph in Figure 29B shows an expanded view of the slot signature region where the distinct polarity reversal can be seen.

FIGURE 29. C-SCAN PRESENTATIONS OF ECP SIGNATURES FROM HOLE F, DISK 6S7833 SHOWING A CRACK AND A SLOT
